Coastal Structures - Puerto Rico

J. Morelock and B. Taggart

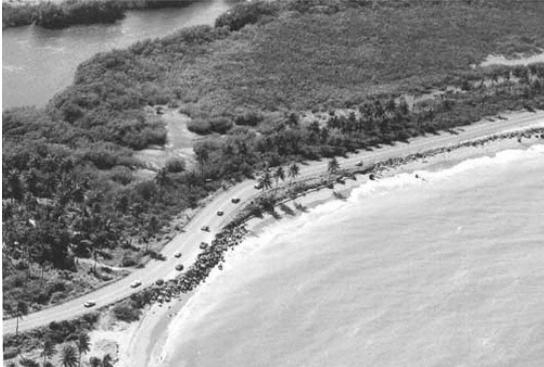
Riprap of boulders

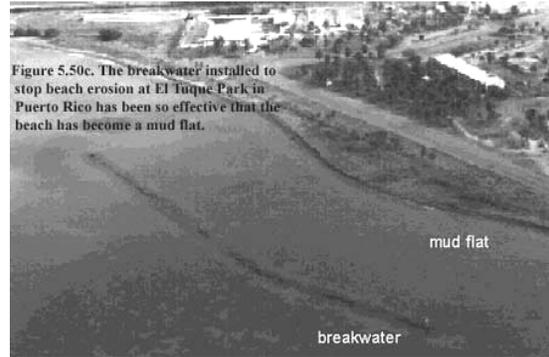
breakwater

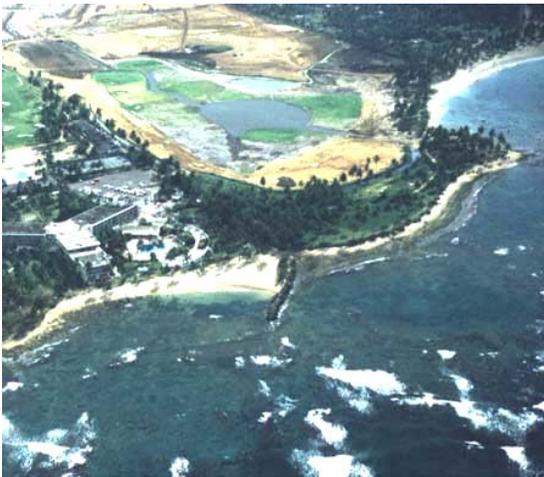
Groyne

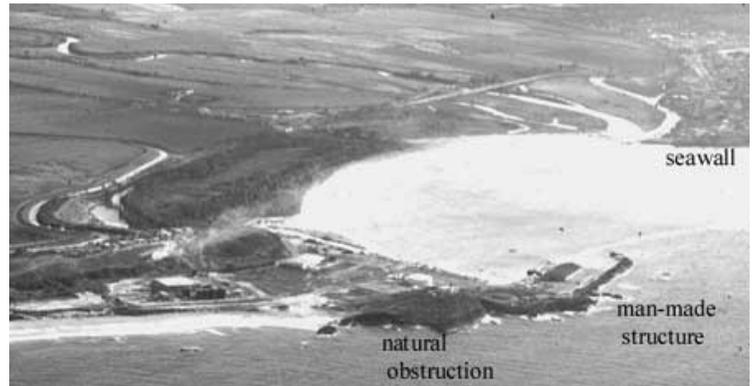
seawall - harbor

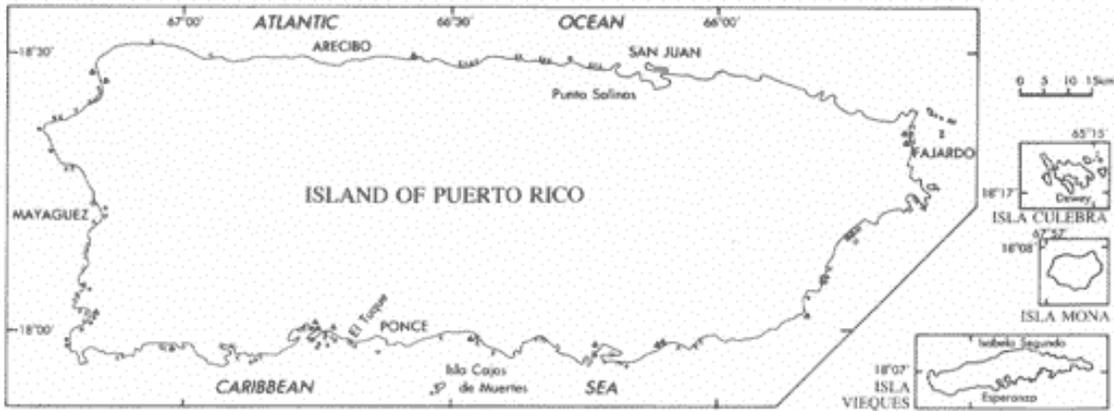
Riprap has been emplaced around much of Puerto Rico's coastline (Figure 6). It is normally in the form of rock fragments ranging from 0.5 to 1.0 m in diameter, but may also include car bodies, broken highway concrete, old tires, and kitchen sinks. There are numerous docks on the west, south, and east coasts, but wave conditions limit the number of north coast docks. Jetties are associated with most of the harbours, and are also used at points of river discharge and in areas where sand-drift trapping has been approved.

Figure 6. observed riprap

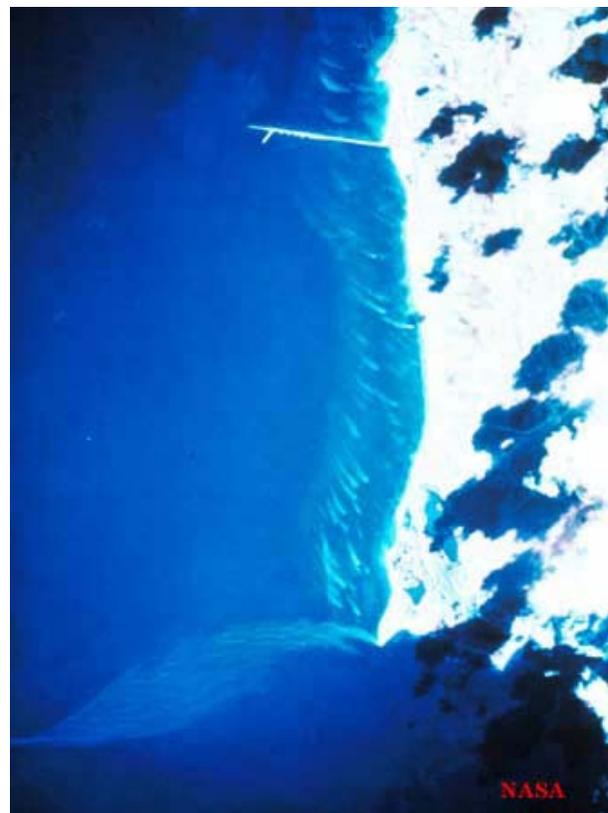
- a 610 m long concrete jetty on the northwest coast built during WWII to be used as a dock for naval vessels (Figure 7)
- a bulkhead and dock at Isabel Segunda
- a pier supported on pilings at Esperanza

Figure 7. Concrete jetty (groyn) on north side of Vieques

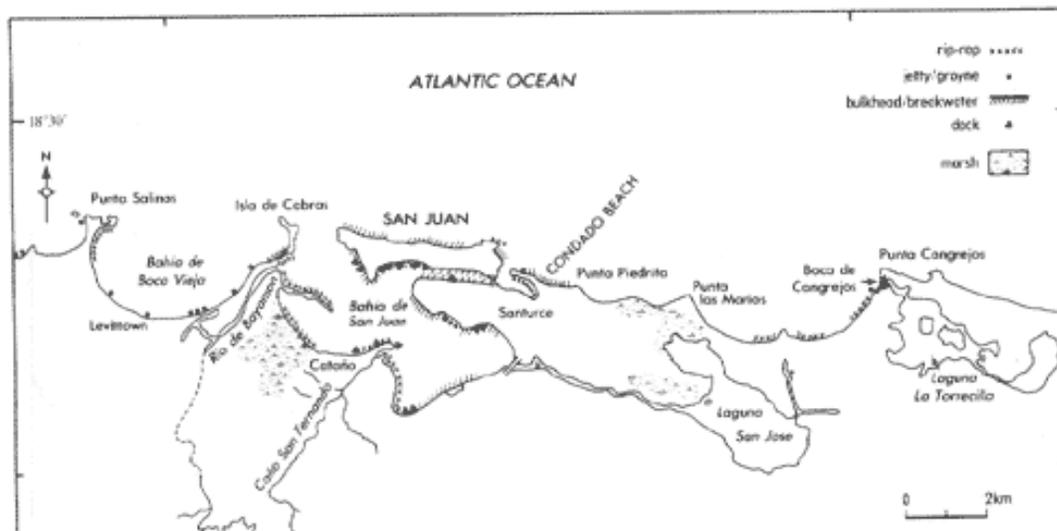
More than half of the coastline between Punta Salinas and Punta Cangrejos (encompassing the Greater San Juan area) has been subjected to structural modification (Figure 8). The activity has been concentrated in Bahía de San Juan, Bahía de Boca Vieja, and along the coast from Punta del Morro to Punta Piedrita.

Figure 8. San Juan structures

In Bahía de San Juan the construction is dominantly bulkheading and docks related to both commercial ship facilities and to residential and commercial buildings. Because Bahía de San Juan is very protected and encased in vast quantities of concrete, little erosion has occurred. In Bahía de Boca Vieja, construction has been for flood control, recreational facilities, and protection from erosion. The discharge of the Río Bayamon was diverted from Bahía de Boca Vieja to Bahía de San Juan by construction of a solid causeway between the mainland and Isla Cabras (Figure 9). This has changed the shape of Bahía de Boca Vieja and its sediment input budget. Additional changes have been introduced by the construction of three jetties (Figure 10) and a flood control channel at the south center of the bay shoreline, two jetties on the shore to the east, three to the west, and emplacement of solid riprap along the east shore of Punta Salinas. Measurements of coastline change made from aerial photographs spanning 25 years have shown erosional rates of 2.0 to 3.0 m per year in different parts of Bahía de Boca Vieja. Morelock 1978

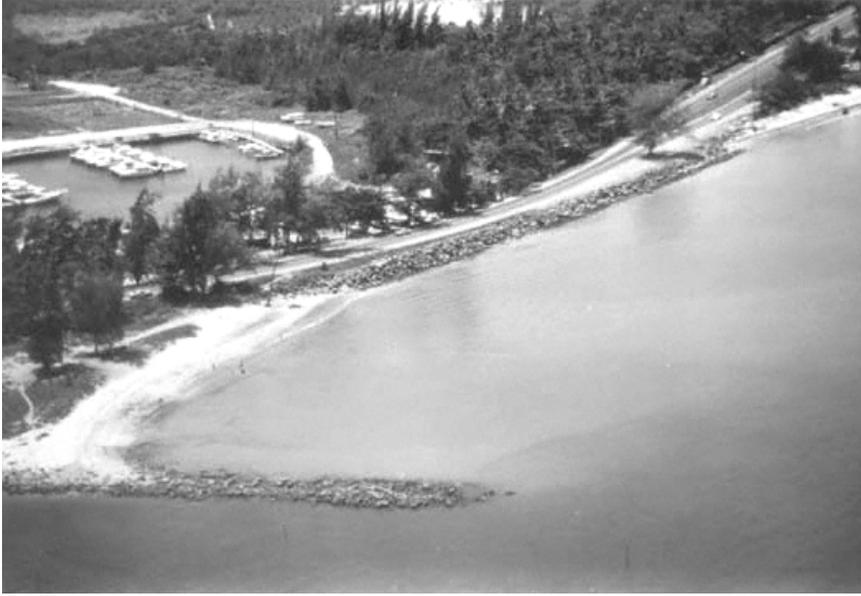
Many individual residential areas have been bulkheaded in the upper beach to protect property. The jetty and bulkheading at Boca de Cangrejos constitutes a major change in shoreline conditions (Figure 11). This was accompanied with the opening of Boca de Cangrejos channel to release swamp water into the ocean and create a marina. This activity killed the reef encrusted eolianitic offshore, and reduced the resistance of the coast to erosion.

Figure 11. Boca de Cangregos jetty and riprap

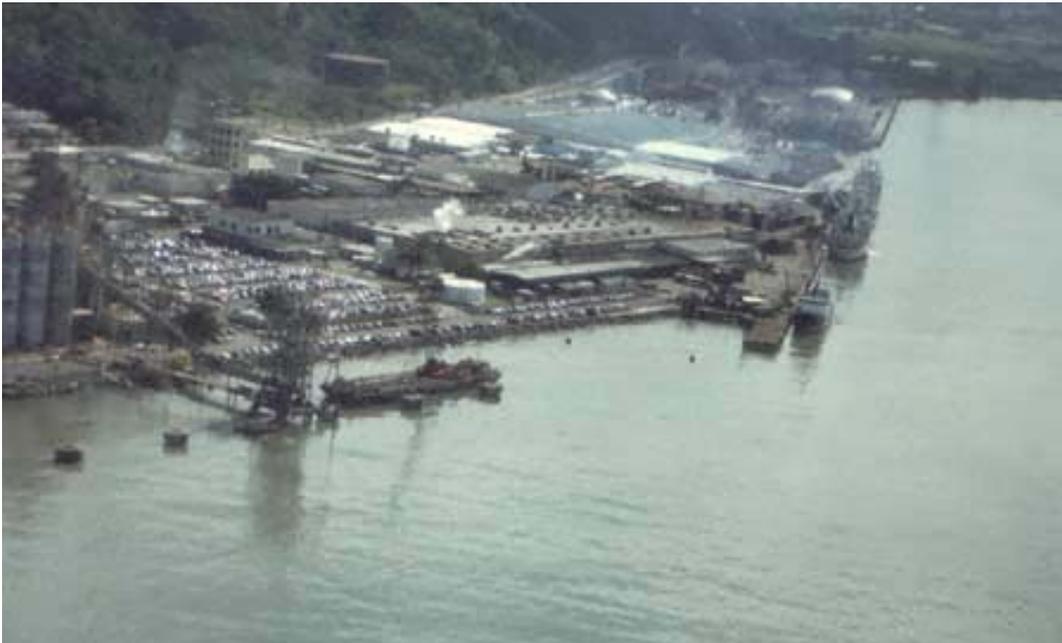
Coastal modification at Mayagüez includes extensive bulkheading in the Malecon (Figure 12) industrial area and Mayagüez Harbour, channelization of the Río Yaguez, and riprap from the center of Bahía de Mayagüez to the north of the Río Guanajibo (Figure 13). The solution to beach erosion at Mayagüez has been replacement of the beach with rock riprap. This is a situation in which the riprap had to be continuously extended as each effort created more erosion outside of the protected area.

Figure 12. Mayagüez harbor, docks and seawall

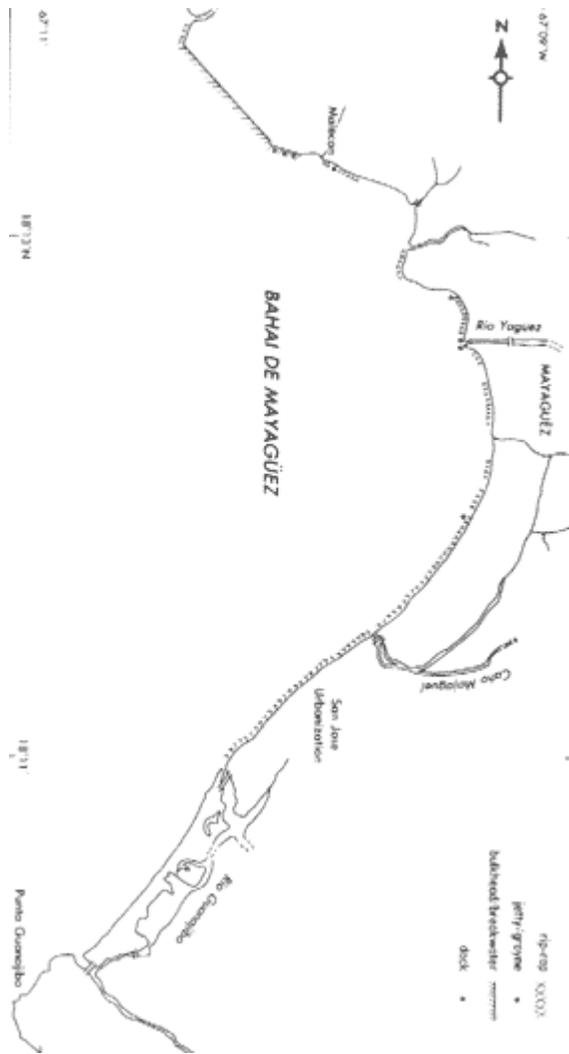
Figure 13. Structures at Mayagüez

The deep harbour channel (more than 10 m deep) at Mayagüez separates the Añasco and Mayagüez beach systems. Sand at the terminus of the Añasco beach accumulates against the Malecon bulkhead. Because of the lack of sediment supply (there is no upstream source and no effective offshore source – it has a very low CaCO₃ content) Mayagüez beach is susceptible to erosion. The construction of houses close to this shoreline, often over the berm, was a certain prelude to requiring riprap.

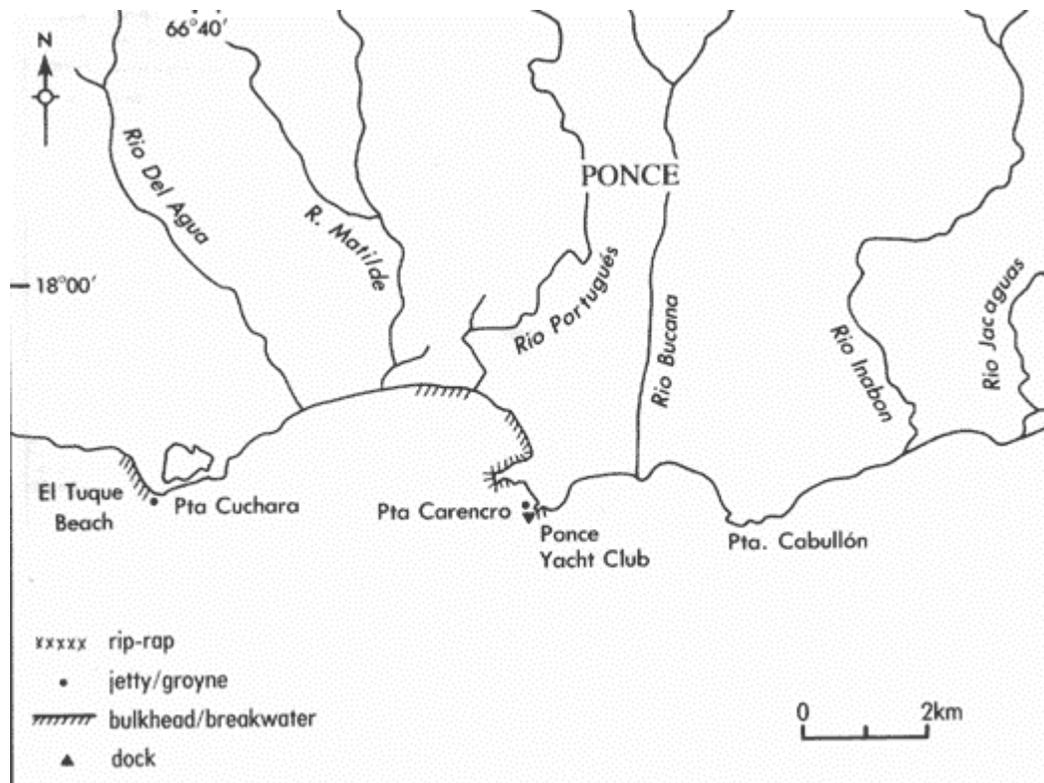
Commercial harbour and docking facilities, city-front riprap and bulkheading, and yacht facilities account for most of the coastal modifications in Ponce (Figure 14). Until recently there was removal of coastal sands from behind the beaches, resulting in accelerated erosion by washover and breaching. The ocean fronting the urban area is heavily bulkheaded and the harbour area is lined with concrete.

The Ponce Yacht Club was constructed over a small barrier reef and the lagoon between this fill and the commercial dock has been bulk-headed. The seaward-facing side of the yacht club consists of riprap composed of broken highway concrete. Jetties have been added to the west tip of the club's "peninsula" to protect a bathing beach.

Figure 14. Ponce structures

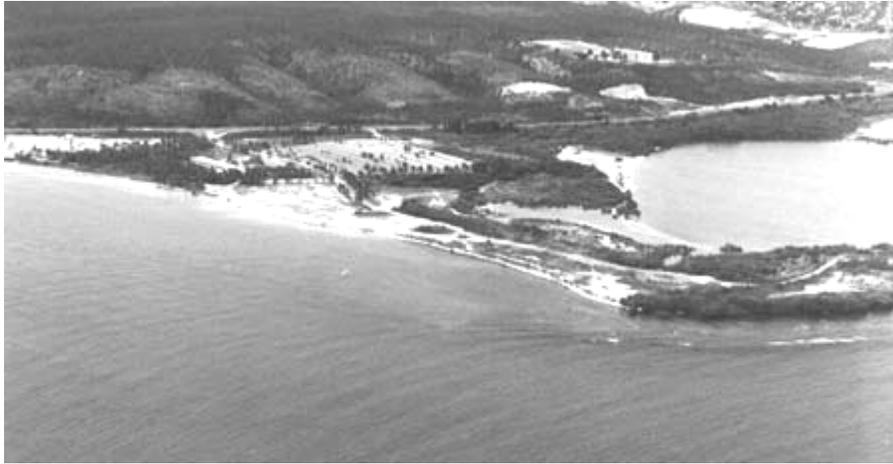
El Tuque Beach, west of Ponce has been modified several times in the past 20 years in attempts to restore it as a public beach and retard erosion (Figure 15). The first attempt consisted of a massive artificial nourishment effort with sand. Unfortunately the grain size did not match the energy environment, and there was more than 7 m per year of erosion after the introduction of the fill [Morelock, 1984](#). The most recent effort involved the construction of offshore breakwaters and a jetty to the south, accompanied by artificial nourishment with dark-mineral rich sand. The beach has developed large erosional scallops during the past year.

Figure 15. Erosion, groyne and breakwater at El Tuque

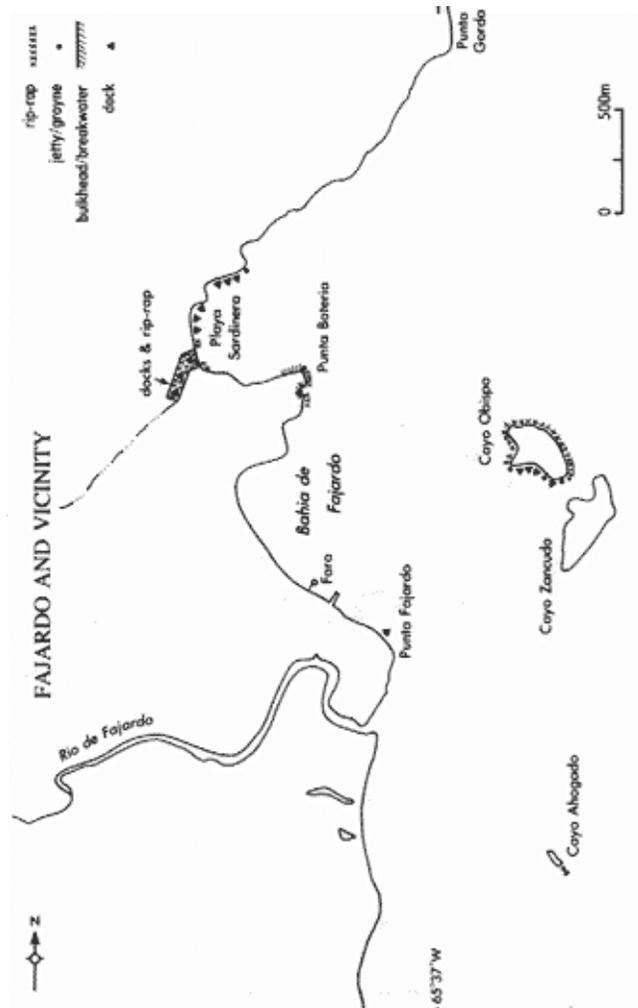
The beaches at Fajardo are relatively narrow and at the town consist of quartz, feldspar, and igneous rock fragments from the Río Fajardo. [Morelock, 1978](#) The beaches north of the town are composed of skeletal carbonate grains deposited behind a fringing reef. Sediment and effluent influx have almost completely killed this reef. Coastal modification includes bulkheading and dock facilities fronting the town, the development of six marinas with extensive (Figure 16).

Figure 16. Fajardo structures

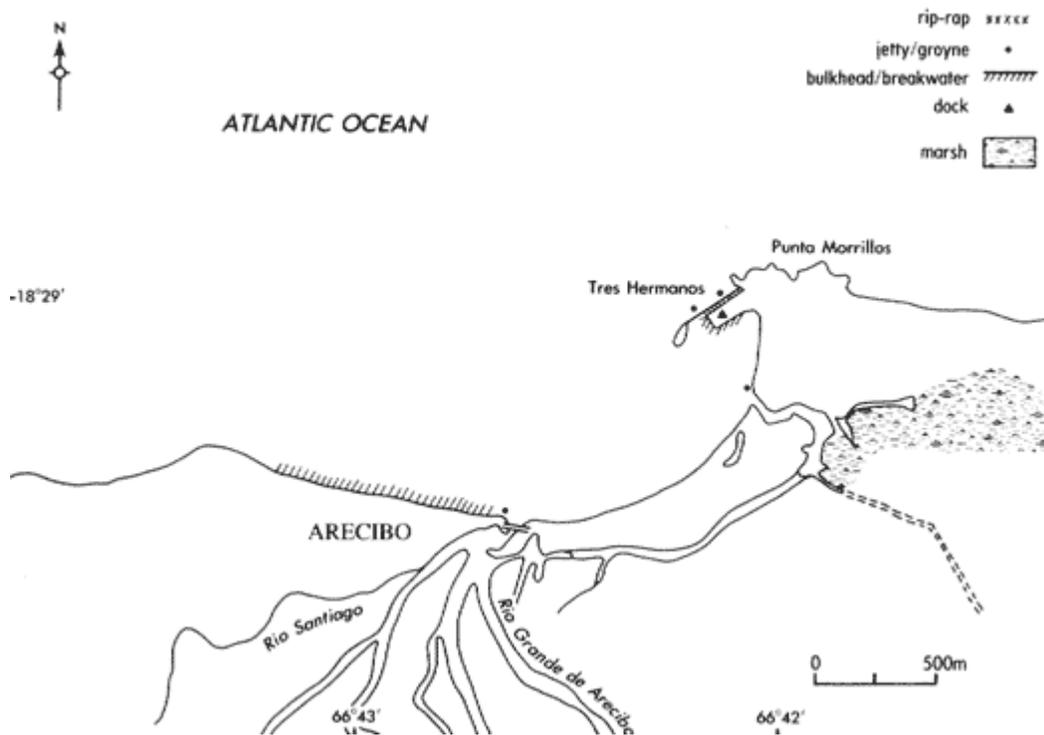
The coast at Arecibo is beach plain, eolianitic, and fill. The addition of fill to an eroding coastline for shore-front urbanization has required extensive bulkheading of the city shoreline (Figure 17). The Arecibo harbour is one of only two on the north coast (Arecibo and San Juan). Eolianite exposures at the east end of the harbour did to extend far enough to form a natural harbour so a rock jetty and concrete dock was attached to the rock, extending westward. This has modified the wave and current regime within the bay and both Briggs ¹⁹⁶¹ and Morelock ¹⁹⁸⁴ accredited the coastal erosion of more than one m/yr for the subsequent 30 years to the change. Recently a controlled and jettied channel has been added at the old river mouth to develop a yacht club.

Figure 17. Structures at Arecibo

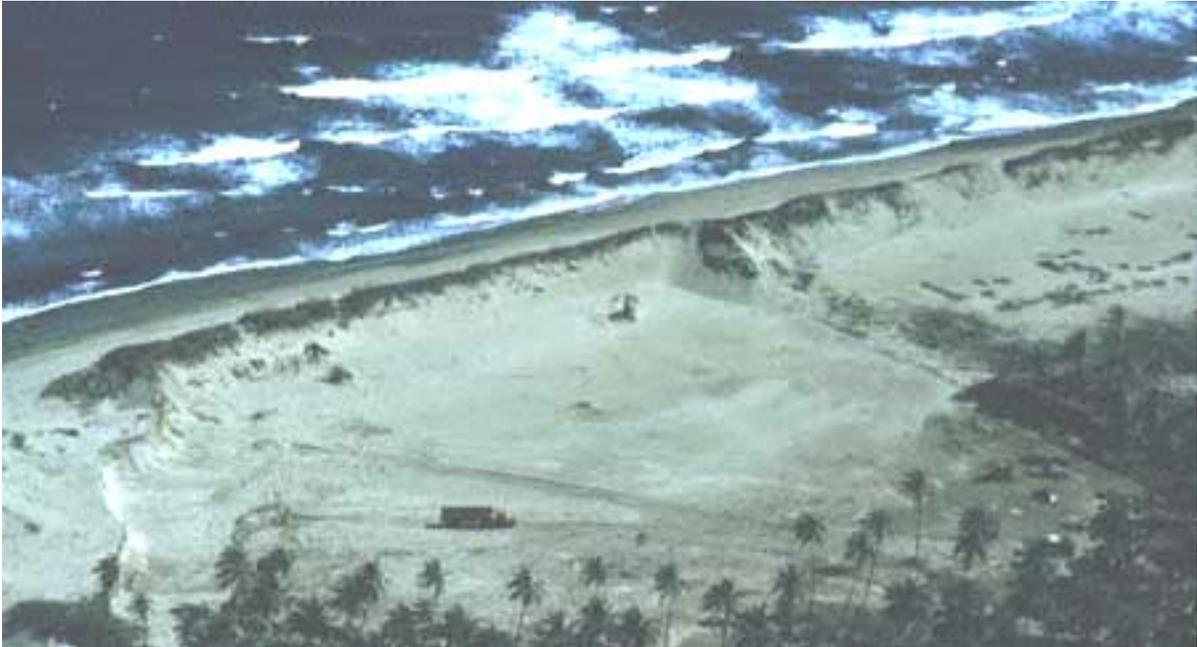
Borrow pits are a common sight at the coast, particularly along the north coast where there are large coastal dune systems (Figure 18). Sand at these sites is commonly extracted to a depth well below sea level and to within several metres of the beach, leaving only a thin barrier between the borrow pit and the ocean. The result has been an overtopping by storm waves with subsequent breaching of barriers. Flooding of lowlying backshore areas, accelerated shoreward erosion, and loss of land followed. This loss of land occurs not only in the immediate vicinity of the extraction because of breaching but also down-drift because of the reduced ability of the shore to resist wave attack as the beaches diminish.

Figure 18. Coastal dune mining, northwest Puerto Rico
